**IAN WHITE**  
ACCREDITED MARINE SURVEYOR®

**1988 CS 36 Merlin**

# Report of Marine Survey

September 11, 2015

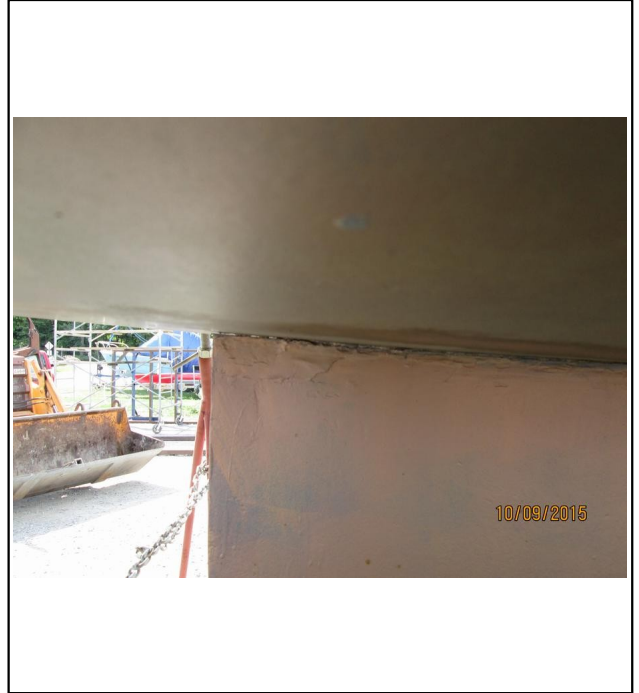
Keel is attached directly to hull.	
FINDINGS	RECOMMENDATIONS
<p><b>Keel to hull joint is roughly faired. The keel to hull joint is open at the aft end 6-8 inches. Keel bolts are dirty but show no signs of corrosion. Reportedly, at construction, the top of the keel was dressed with FRP chopped strand filler and then attached to the hull with keel bolts. No motion in the keel was detected as the vessel was hauled and placed on blocks. While the gap at the aft of the keel is a concern, there are no other indications that the current installation is not sound.</b></p>	<p><i>Investigate further. Repair as necessary. Full service by an expert.</i></p>

Gap between keel and hull.

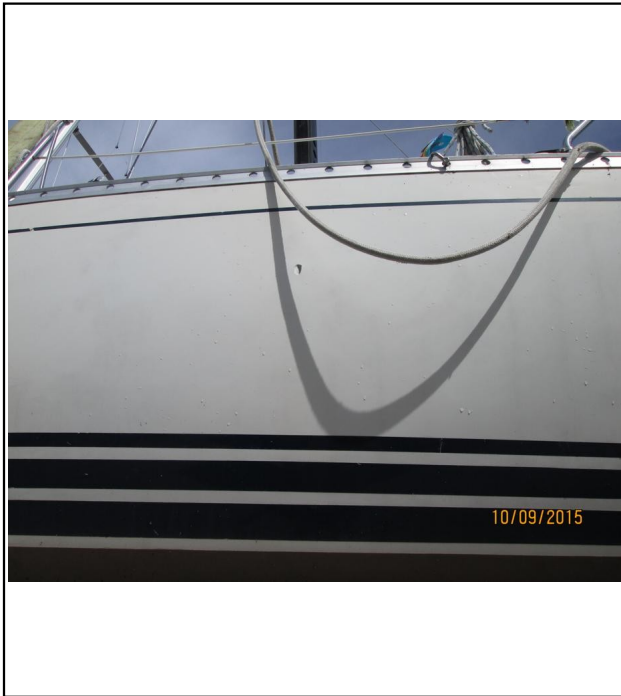
Penetration damaged sighted on port side aft 18 in. above waterline.

FINDINGS	RECOMMENDATIONS
<p><b>Penetration damage.</b></p>	<p><i>Further investigate and repair as necessary.</i></p>

Hole in topsides, port side.

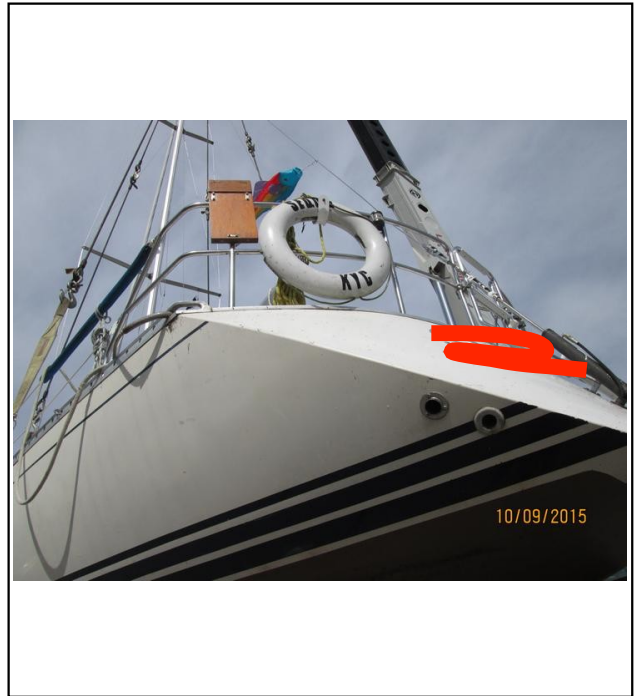
Sound	
FINDINGS	RECOMMENDATIONS
Port side gel coat damage at corner.	Further investigate and repair as necessary.

Chips in transom

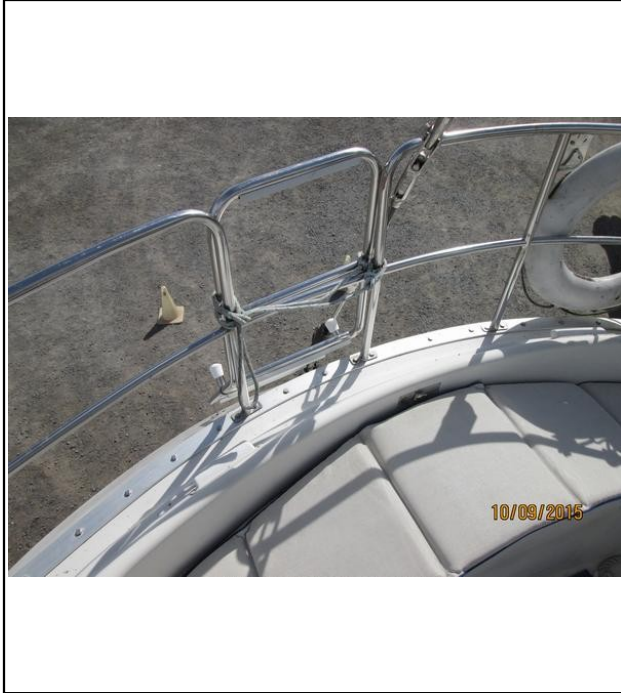
Boarding ladder is tied in the up position.	
FINDINGS	RECOMMENDATIONS
<b>Not possible to re board the vessel from the water.</b>	<i>Arrange ladder so that it can be released from the water.</i>

The stern boarding ladder is tied into the up position and is not accessible from the water.	
FINDINGS	RECOMMENDATIONS
No means or re boarding the vessel from the water.	Arrange the release of the boarding ladder so that it can be released from the water.

**Boarding ladder accessibility.**

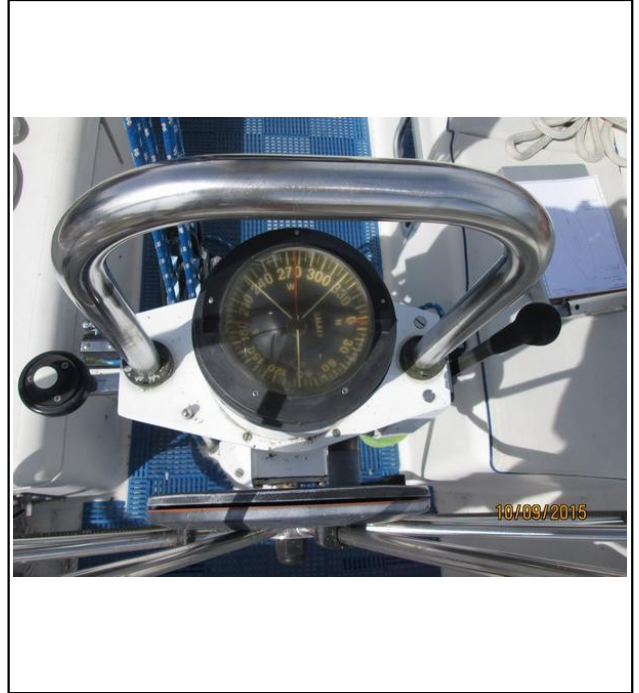
6" Galaxy.	
FINDINGS	RECOMMENDATIONS
<b>Compass is cloudy and sun damaged.</b>	<i>Refit, refinish, refurbish, or replace as necessary.</i>

**Compass clouded.**

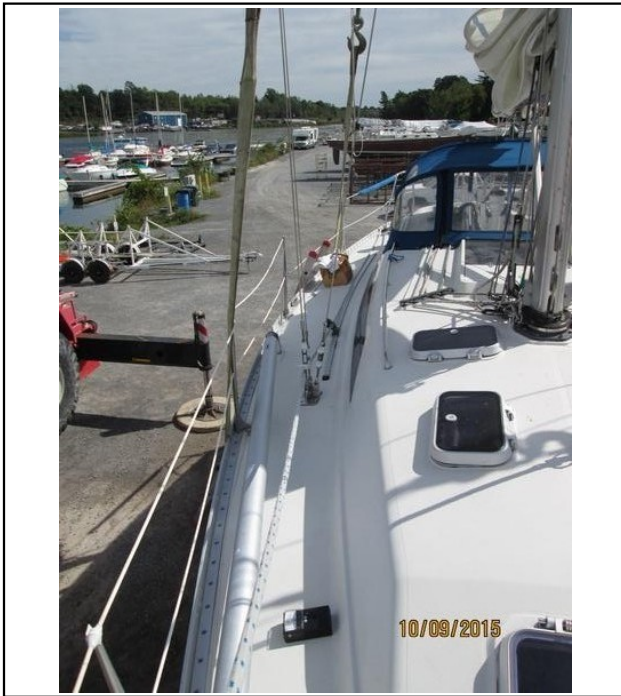
The entire area of the deck, cabin top and cockpit was tested and found to be 5-10 except for the starboard side deck from abeam the head hatch to abeam the starboard sheet winch which was found to be 20 -30 generally 25. Soundings of this area compared to the opposite deck are indicative of a presence of moisture in the lay up.

FINDINGS	RECOMMENDATIONS
Higher moisture readings.	Investigate further to determine the source of water penetration to the deck and take steps to repair so as to prevent further damage. Monitor deck condition on an annual basis and repair when/if necessary.

**High moisture readings from meter aft to sheet winch.**

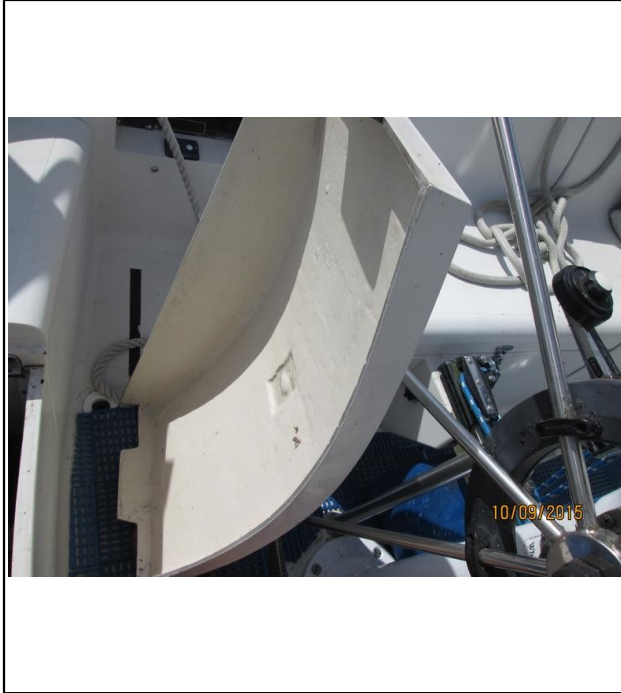
LPG.	
FINDINGS	RECOMMENDATIONS
<b>System is not fully compliant with ABYC standards.</b>	<i>Refit propane locker and equipment in accordance with ABYC A-1. Tanks should be in a top loading locker with latched and gasketed lid. The locker should be dedicated to the storage of propane. The locker should be sealed from the vessel interior and drained directly overboard with a drain located in the bottom of the storage container. The tanks should be equipped with regulator, pressure guage and solinoid cutoff switch controlled from the device.</i>

**propane locker**

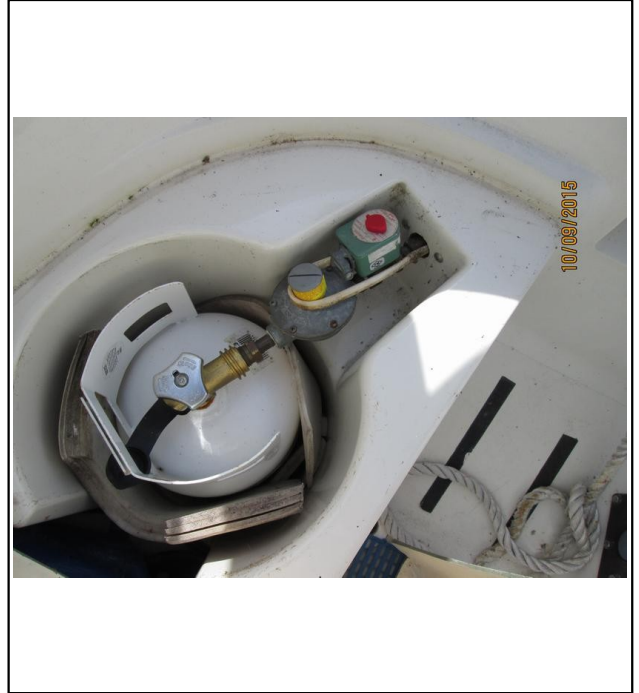
**No pressure guage.**

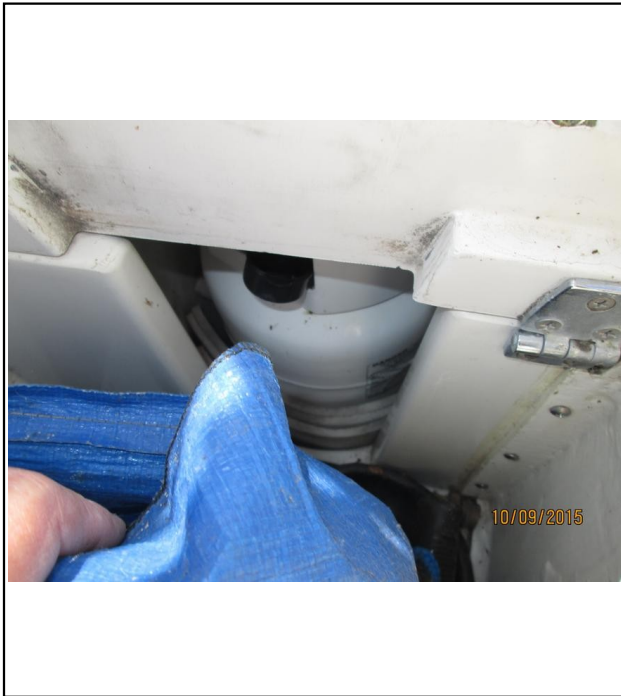
**Propane locker exposed to center locker.**

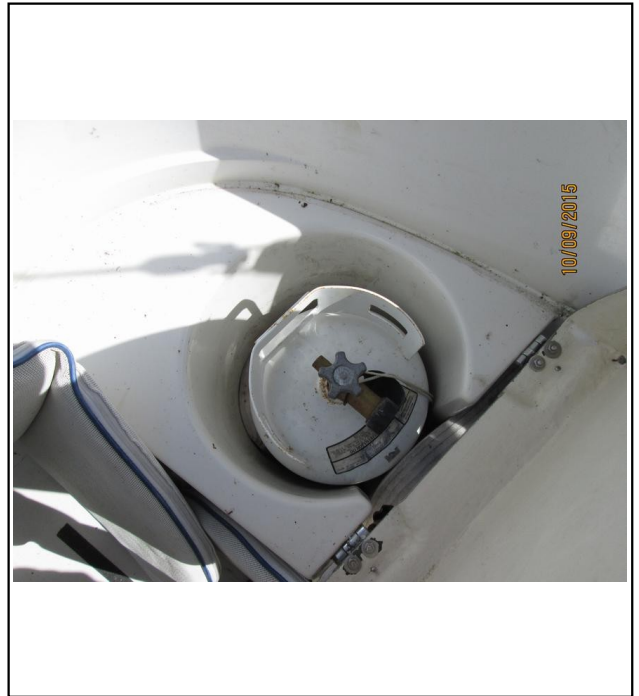
**Spare tank locker.**

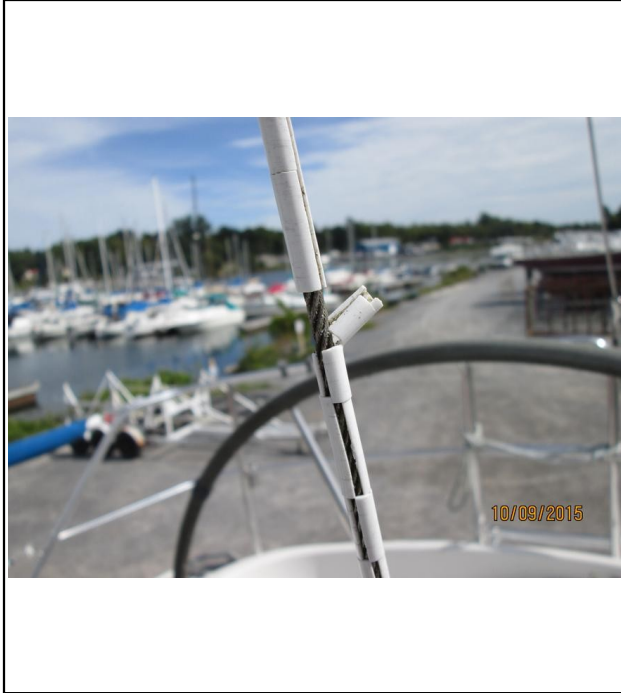
Mainsheet traveler forward of wheel. Appeared serviceable.	
FINDINGS	RECOMMENDATIONS
Cable extension used to connect sheet to boom is SS wire covered with vinyl. Vinyl is cracked, cable exposed appears to be deteriorating.	Investigate further and repair or renew as necessary.

Cable attachment to main sheet.

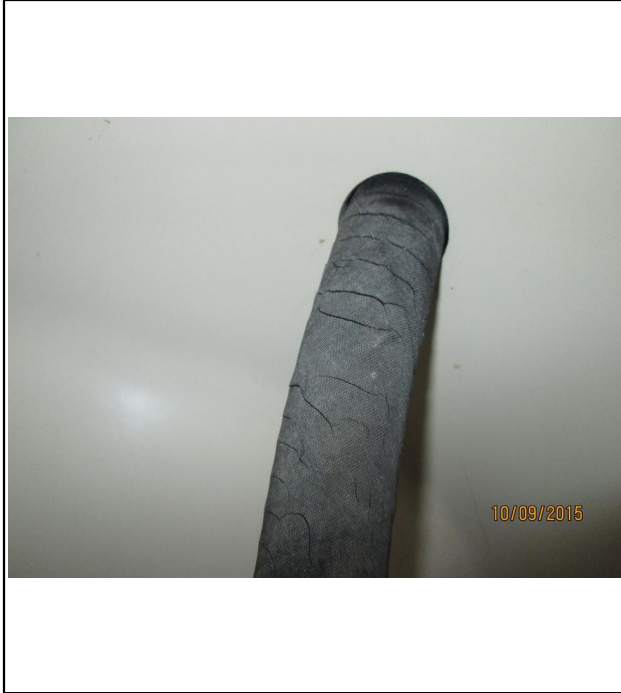
Yes, appears serviceable where sighted.	
FINDINGS	RECOMMENDATIONS
<b>Raw water intake hose is cracked.</b>	<i>Further investigate and repair as necessary.</i>

Cracked raw water hose for head.

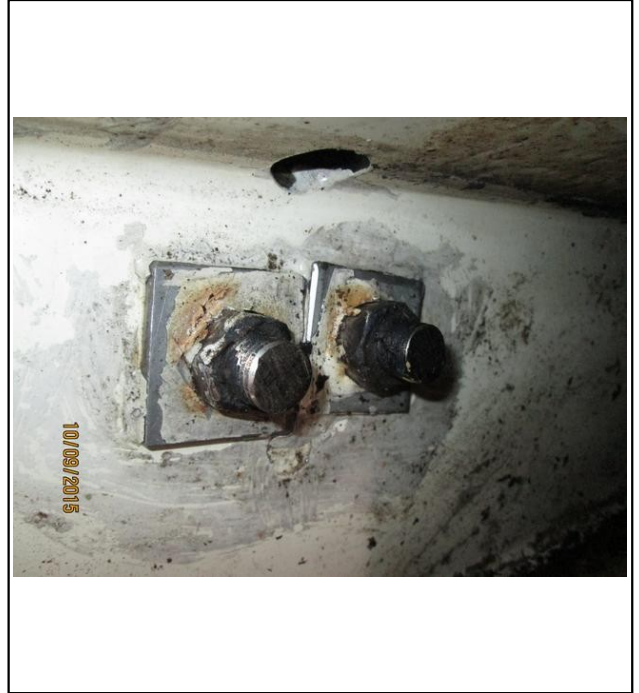
Aft keel bolts.

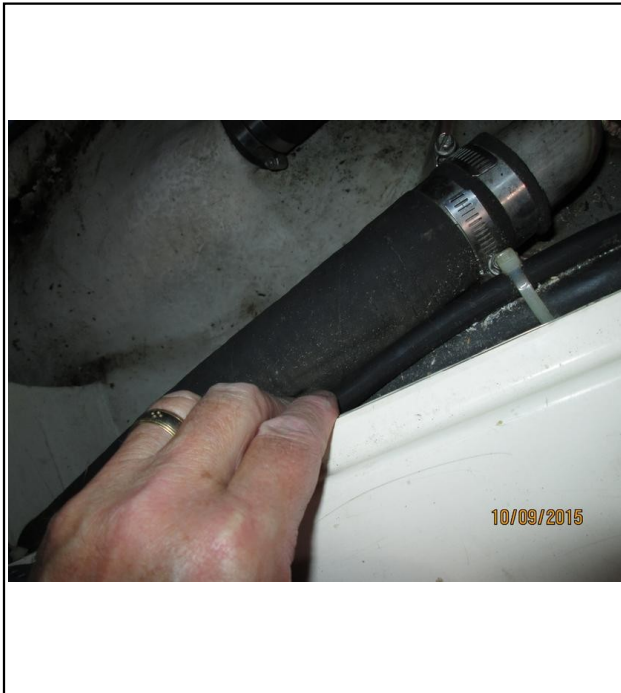
The Aqua lift Vetus type exhaust system was serviceable where sighted.	
FINDINGS	RECOMMENDATIONS
<b>Flexible exhaust hose from muffler to exit point is starting to crack and deteriorate.</b>	<i>Refit, refinish, refurbish, or replace as necessary.</i>

Cracked exhaust hose.
