**1969 Seafarer 31**

# Report of Marine Survey

1969 Seafarer 31

[REDACTED]  
May 01, 2014

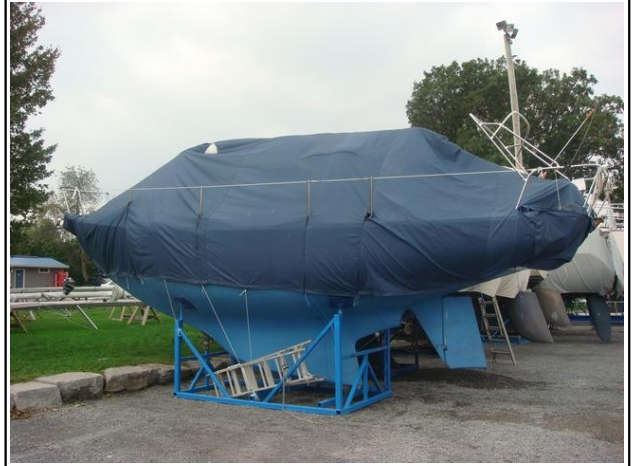
Cradle and Cover.JPG

Cradle sighted. New winter tarp sighted.

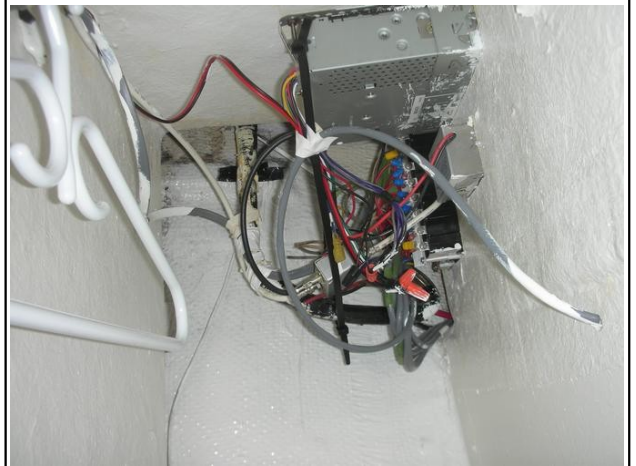
Twist on type sighted behind panel.

Twist on type sighted behind panel.	
FINDINGS	RECOMMENDATIONS
<b>Twist type connectors in use behind panel.</b>	<i>Replace twist on type connectors with marine approved connectors in accordance with ABYC E-11.</i>

Twist Caps behind Panel.JPG
